**2005 Operations, Maintenance,
and Monitoring Report**

**NAOMI OUTFALL
MANAGEMENT**

State Project Number BA-03c
Priority Project Lists 5

June 2005
Jefferson & Plaquemine Parishes

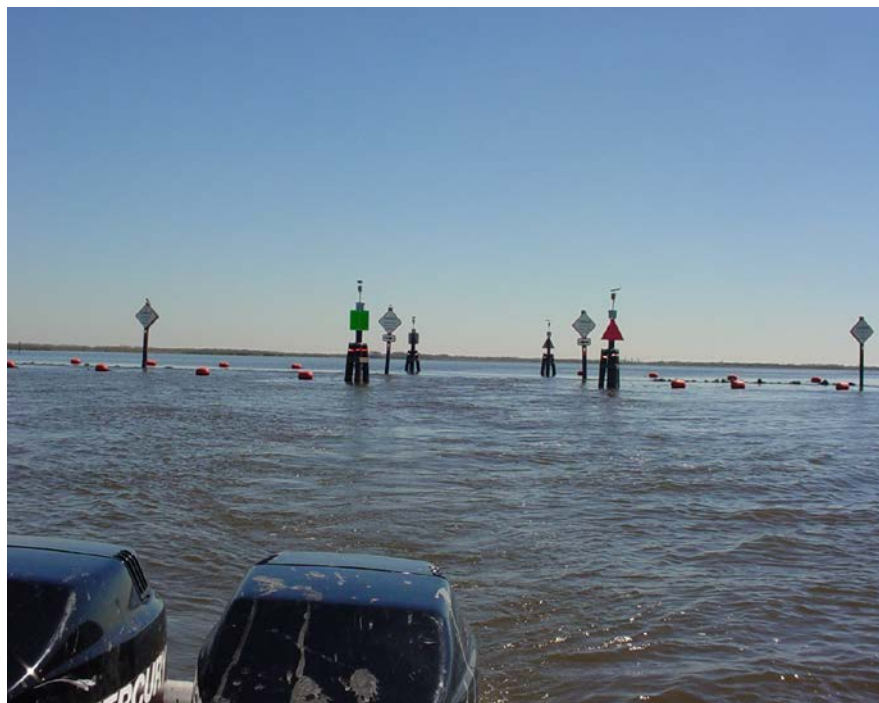
Photo No. 1

There was no visible change in the structure from the last inspection. Rocks are still at approximately the same elevation and continuing to function as designed (appendix a, photograph 1).

All pilings visually appeared to be damage-free and in good condition (see appendix a, photograph 1).

All signs appeared to be in satisfactory condition with no indication of significant damage (see appendix a, photograph 1).

All lights appear to be in good condition. It is anticipated that there will be a contract for periodic inspection and repair of lights in the near future (see appendix a, photograph 1).

Goose Bayou Canal Weir looking East

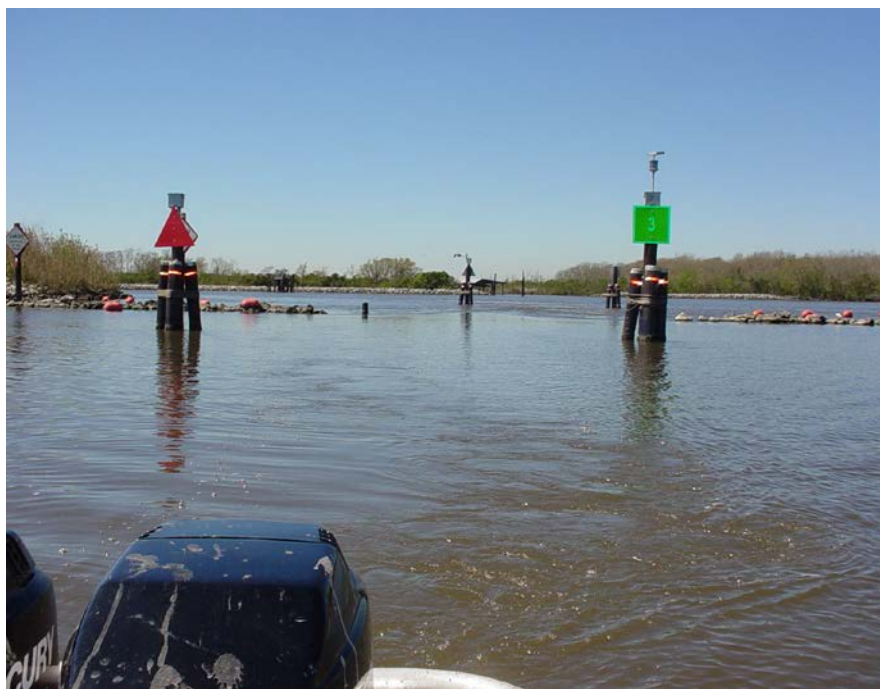
Photo No. 2

The navigation signs were in good condition. The two warning signs in the boat bay of the weir were gone. The work to replace these signs is currently being contracted out. The rest of the signs were in good condition.

**Bayou Dupont Canal Weir looking west;
Note the lack of warning signs**

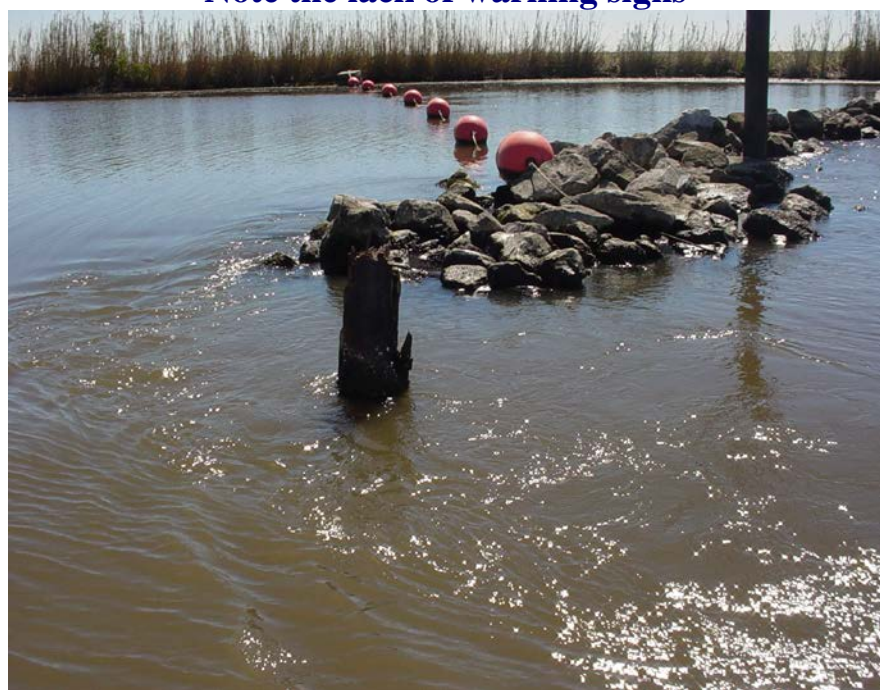
Photo No. 3

All of the warning light piling clusters were in good shape. Both of the warning sign pilings in the weir were missing (Photo No. 3). There was still a little of the piling showing above the water on the right side of the weir when you enter from the BBWW. This work is currently being contracted out. The rest of the warning sign pilings were in good condition.

Damaged Piling on the South of the Bayou Dupont Canal Weir

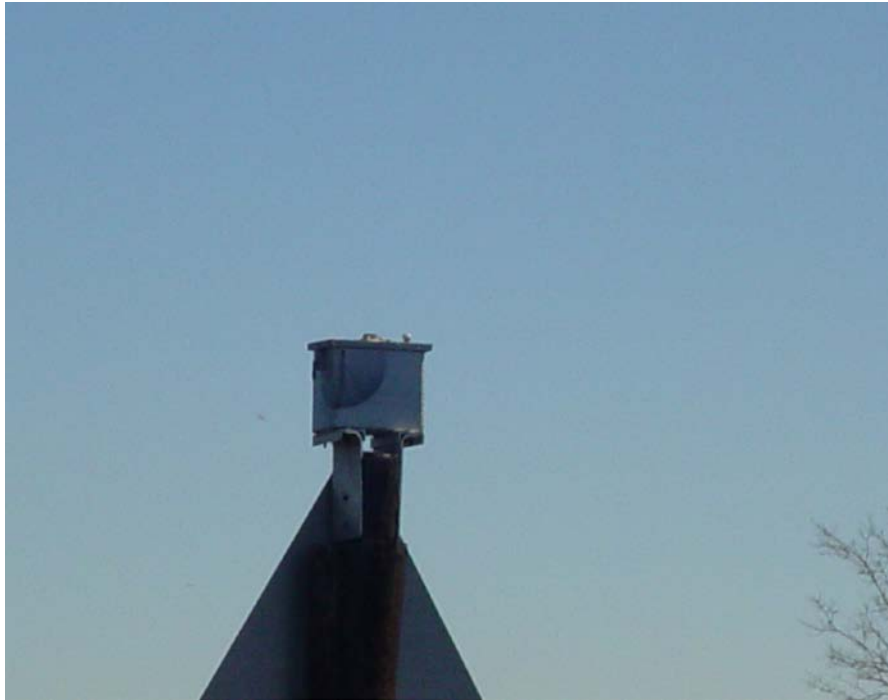
There are currently two lights out of commission at this structure (Photo No. 4 and 5). One has been unlatched and the battery removed and the other has had the light portion above the battery box removed completely. This work is currently being contracted out. As mentioned above there is a contract being worked on for regular inspection and repair of these lights.

Photo No. 4
Damaged light at Bayou Dupont on the East side

A contract for regular inspection and repair of the warning and navigation lights would be helpful for the maintenance of these features. It has been noticed that these lights are very sensitive and are apparently a prime target for vandalism. There also needs to be a better system for locking the batteries into the battery box of the lights. The other problem which is currently being fixed is the damaged pilings at the Bayou Dupont Canal Weir. This makes at least three occasions where one of the two warning pilings was hit. We are hoping to remedy this problem by placing buoys in the same location as the pilings. These buoys should handle a collision a little better, but will be monitored closely to make sure they perform as planned. It may be necessary to look into installing these in areas of high traffic for future projects instead of the pilings with the signs on them.

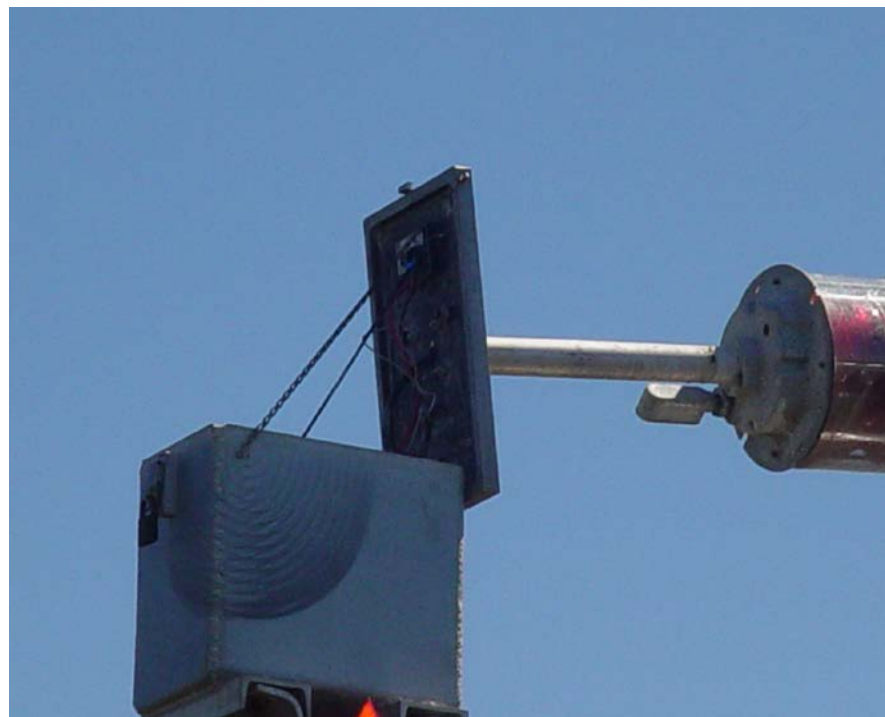
Photo No. 5
Damaged light at Bayou Dupont on the West side
